United States Department of the Interior  
National Park ServiceNational Register of Historic Places  
Registration Form

other names/site number LAKE ROLAND HISTORIC DISTRICT (preferred)

BA-1274

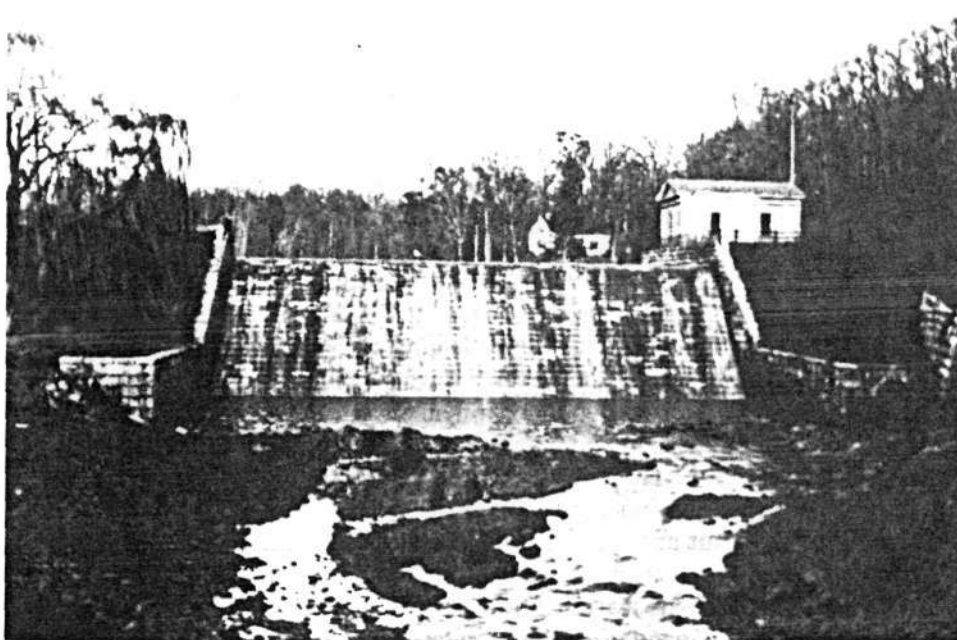
FIGURE 1.  
Lake Roland Dam, June 30, 1907.  
—Barker Collection, Enoch Pratt Free Library

appears essentially the same today 2/12/90  
LRA

The dam was to have been built of earth and wooden cribs, but the decision was made for an "indestructible" dam, and the fates have now spared that boastful structure for some 120 years. The core of the dam was built of heavy rubble work, ground up from "the rough gigantic stone of the neighboring hill-sides." The outer facing was of roughly cut stone or rock ashlar work. A clear waterway 125 feet wide provided the overflow at the top of the dam. Wing walls on each side rose 6 feet above the crest and the wings were entirely

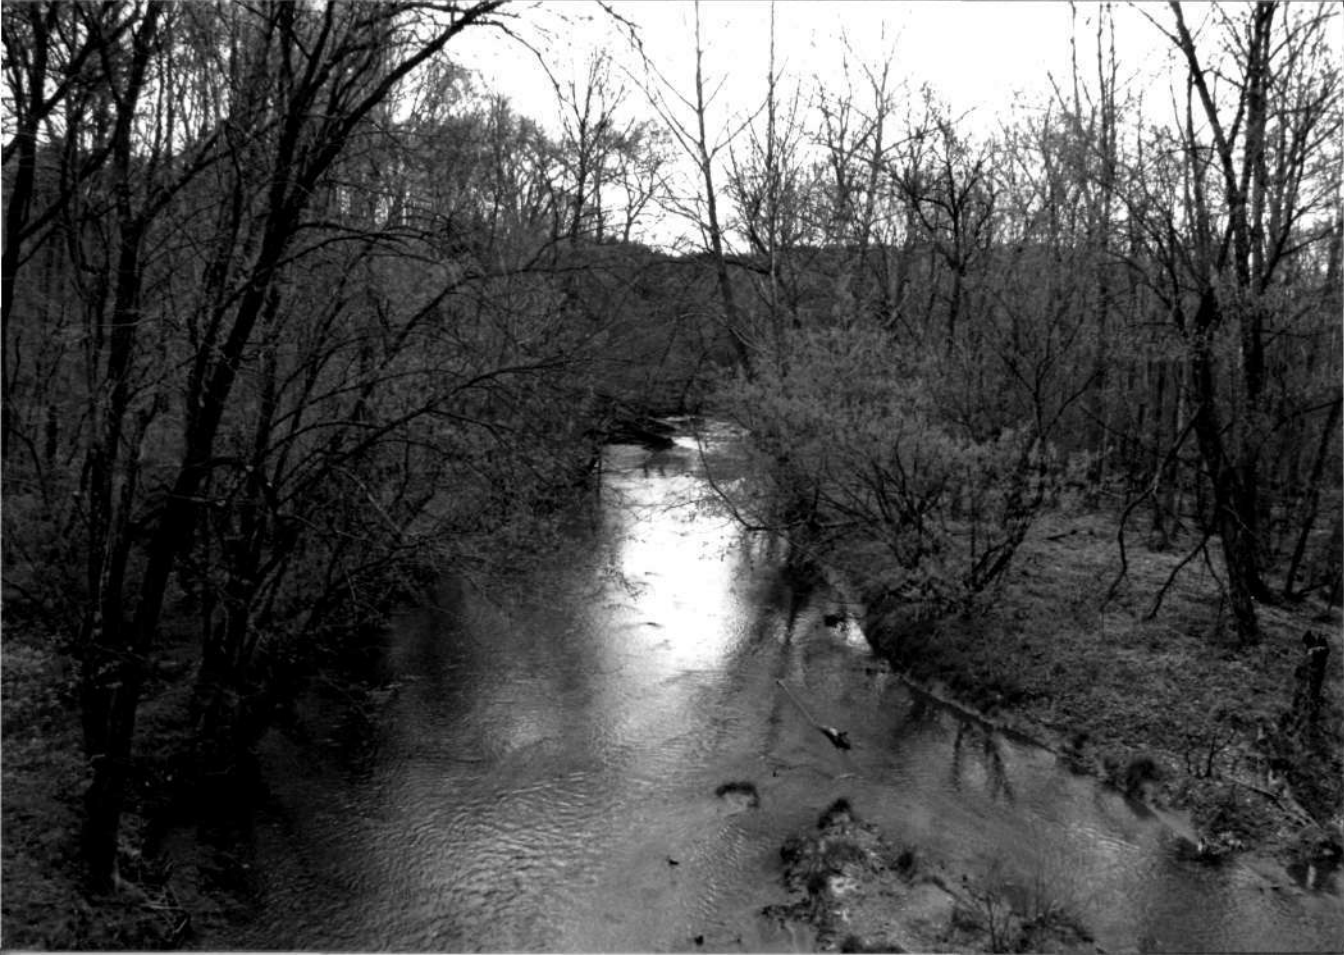
4 of 45

Jones Falls at Girder Bridge Looking North

A circa 1924 steel plate girder bridge rests on circa 1859 rusticated stone abutments at Jones Falls near the western boundary of the historic district. The abutments are constructed of large rectangular hewn stone blocks with rusticated faces. The abutments have corbeled edges and are 21 feet 2 inches wide at the top. Although the abutments are of sufficient width to accommodate two tracks, the current bridge is of single track width and spans 55 feet 7 inches. The ties remain in place and support a recently constructed footbridge. The abutments are unaltered, and a contributing resource with a high level of integrity and historic significance to the nomination. The bridge was constructed after the period of significance, is of uncertain integrity, and does not contribute to the nomination.

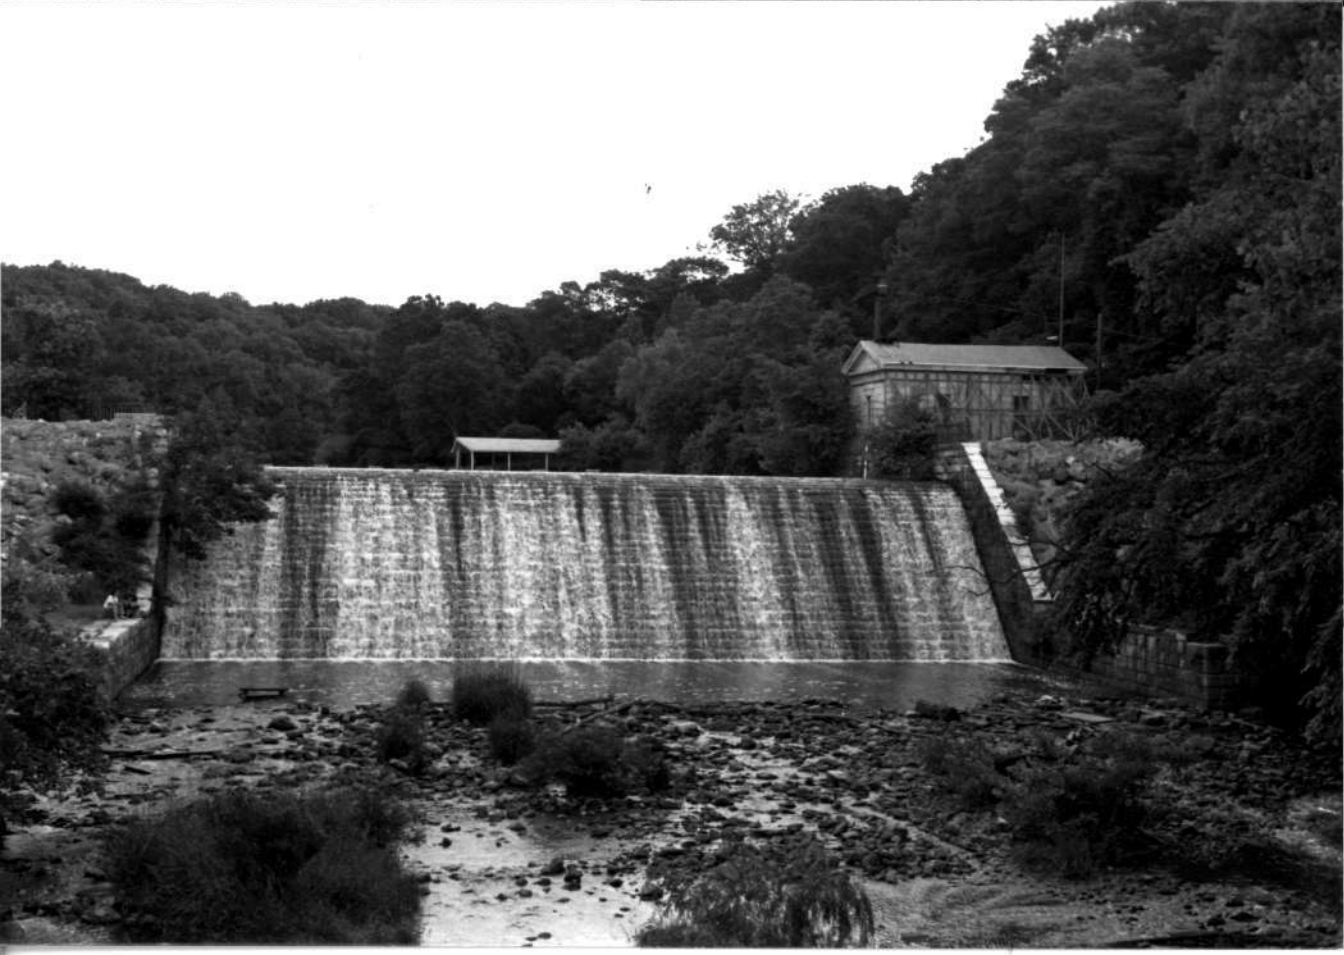
6 of 45

Dam South Elevation

horizontal on the lake side and a front spillway face sloped at approximately 45 degrees on the downstream side. The spillway is curved convexly at the top and concavely at the base. It is of solid rubble stone construction on the interior, and is faced with rectangular rusticated stone blocks. When the lake is full, the water flows over the top of the dam and down the sloped spillway which is approximately 120 feet between abutment walls. The height from the water at the base to the top of the spillway is approximately 40 feet. The dam abutments projecting six feet above the spillway and the walls enclosing the waste weir on the east side of the dam are also constructed with rusticated cut stone blocks. The sloped portions of the dam on both sides of the spillway are covered with boulder sized rip rap. A small secondary rubble stone dam forms a pond at the base of the main dam. The dam and its related structures have not been altered since they were constructed between 1858 and 1861. Some of the coping stones of the abutment walls below the spillway are missing.

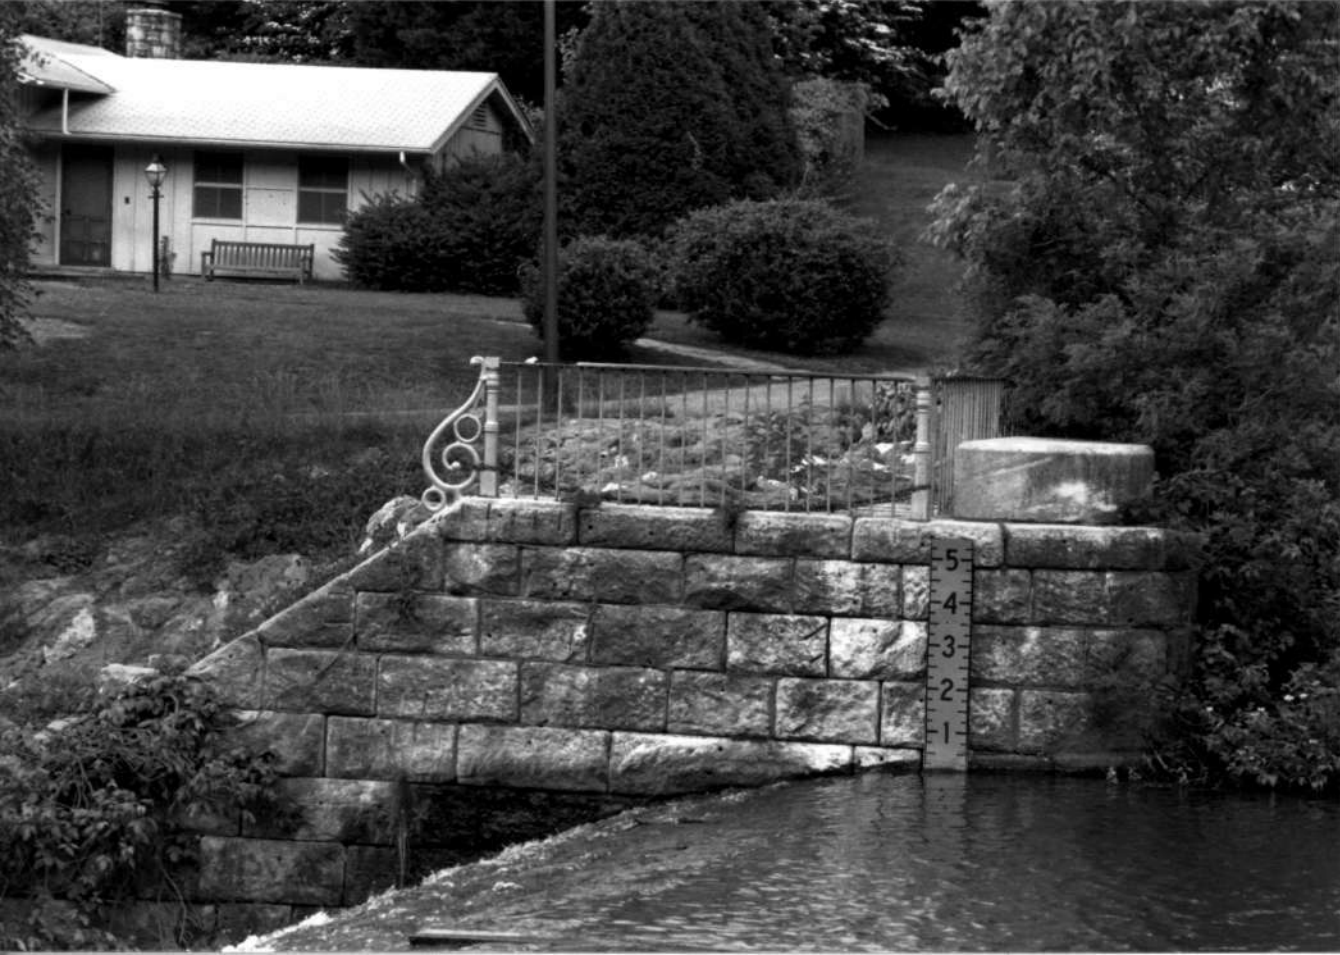
June 1991  
Robert Macht, 6140 Barroll Rd, Baltimore, Maryland 21209  
West Dam Abutment  
8 of 45

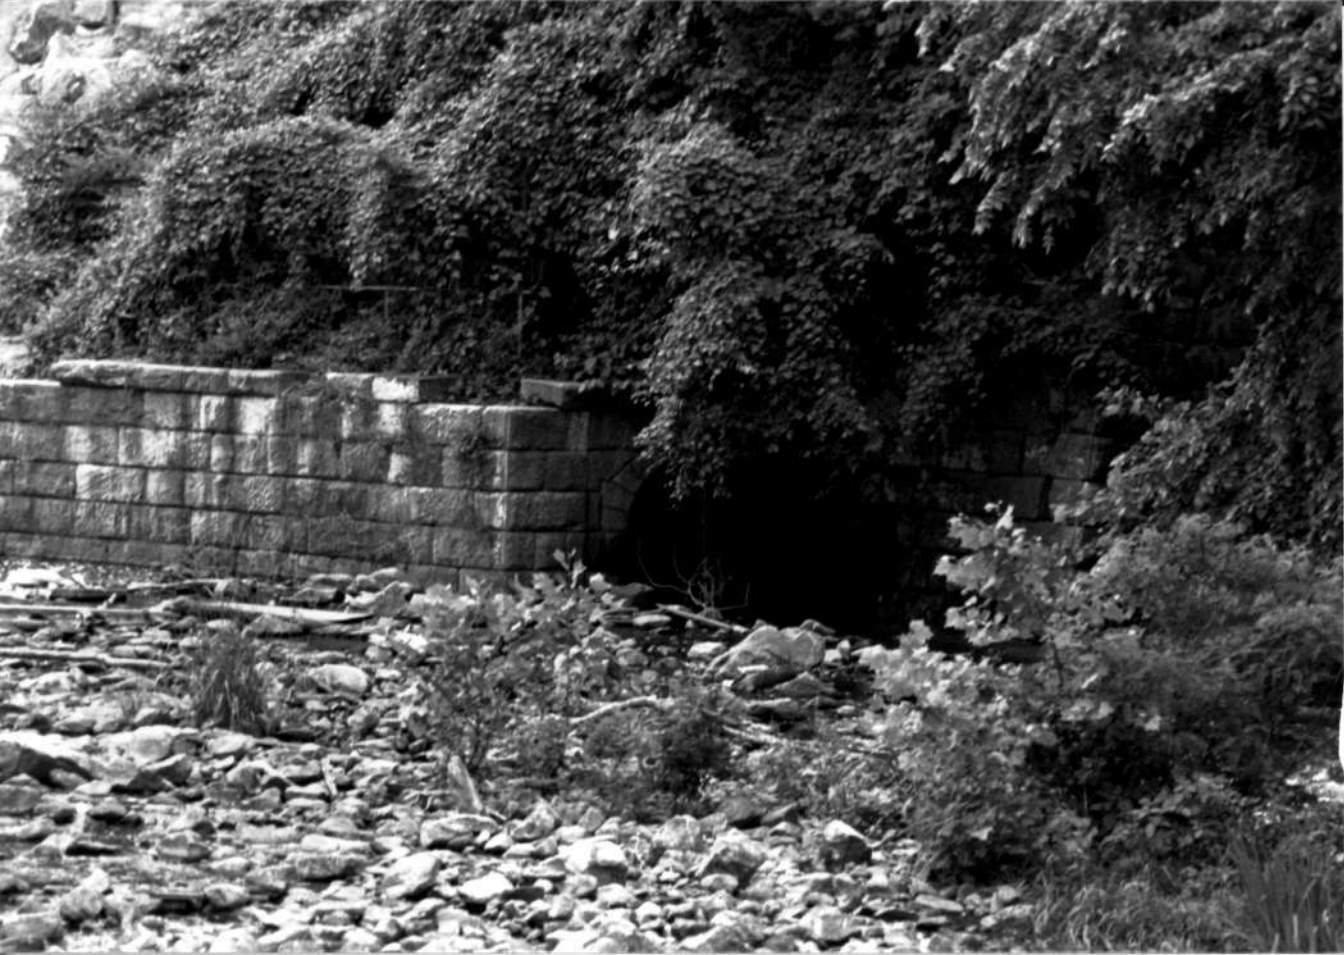
9 of 45

Waste Weir Looking East

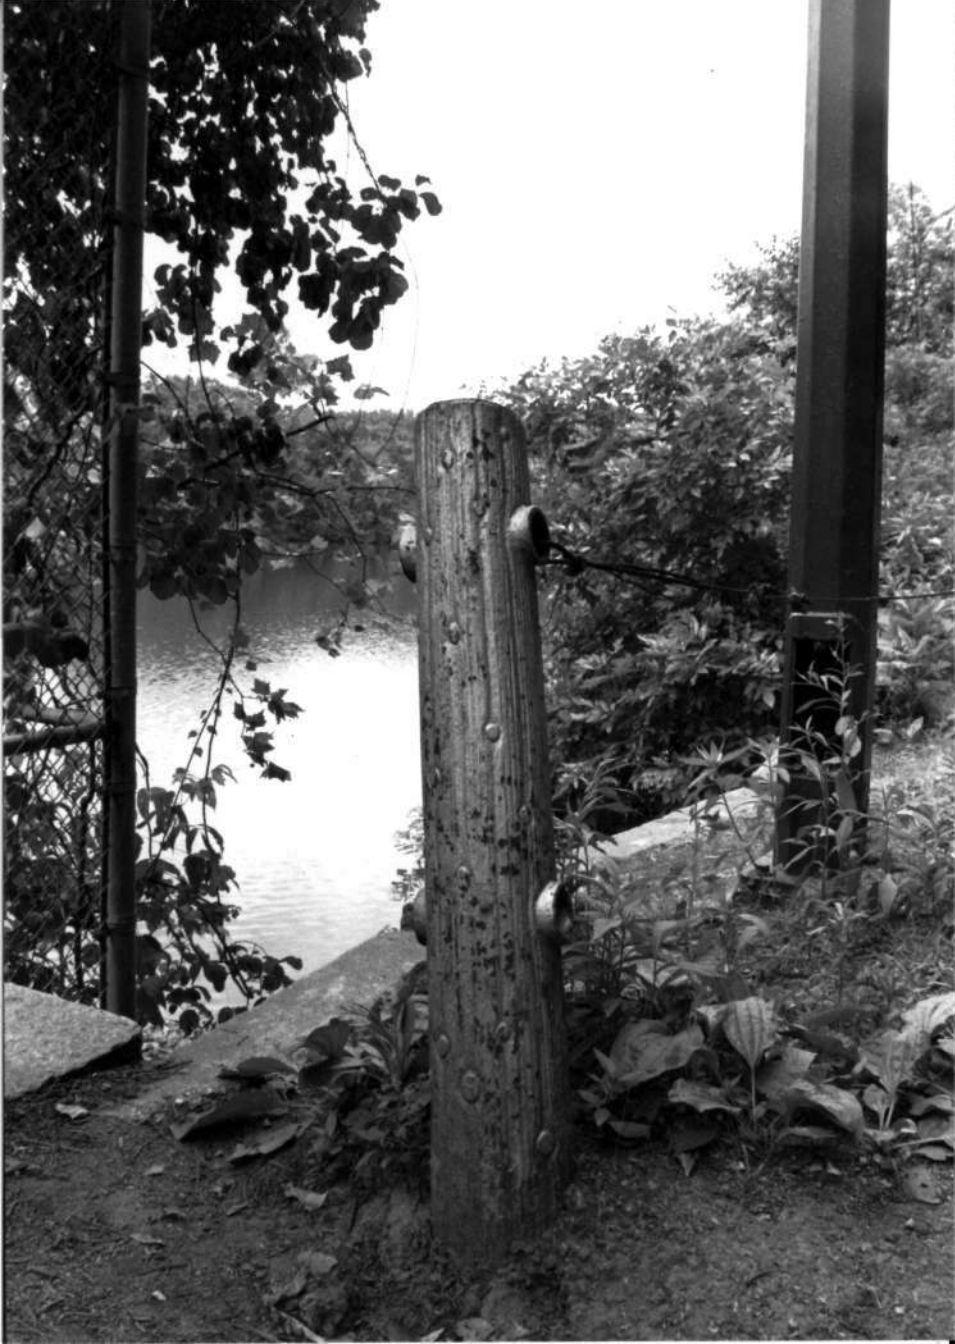
17 of 45

Fence Post at Valve House

A fence with circa 1862 cast iron fence posts lines the west side of Lake Side Drive from the intersection with Hollins Lane to a stone wall south of the valve and continues north of the Valve House. The posts are approximately 4 inches in diameter and in the form of a small diameter wood post with vertically grooved bark, axe hewn top and pruned tree limbs. The posts were originally connected with two horizontal 1½ inch diameter pipe rails. The pipe rails have been replaced with steel cable. The fence is a contributing resource with a low level of integrity and a high level of historic and architectural significance whose contribution could be enhanced by sympathetic restoration. The asphalt paved parking area was constructed circa 1965, and slopes upward toward the east. The rectangular parking area is approximately 60 feet by 200 feet in size, with the long axis in the east-west direction. The parking area was constructed after the period of significance, and is an open-space which does not contribute to the significance of the nomination.

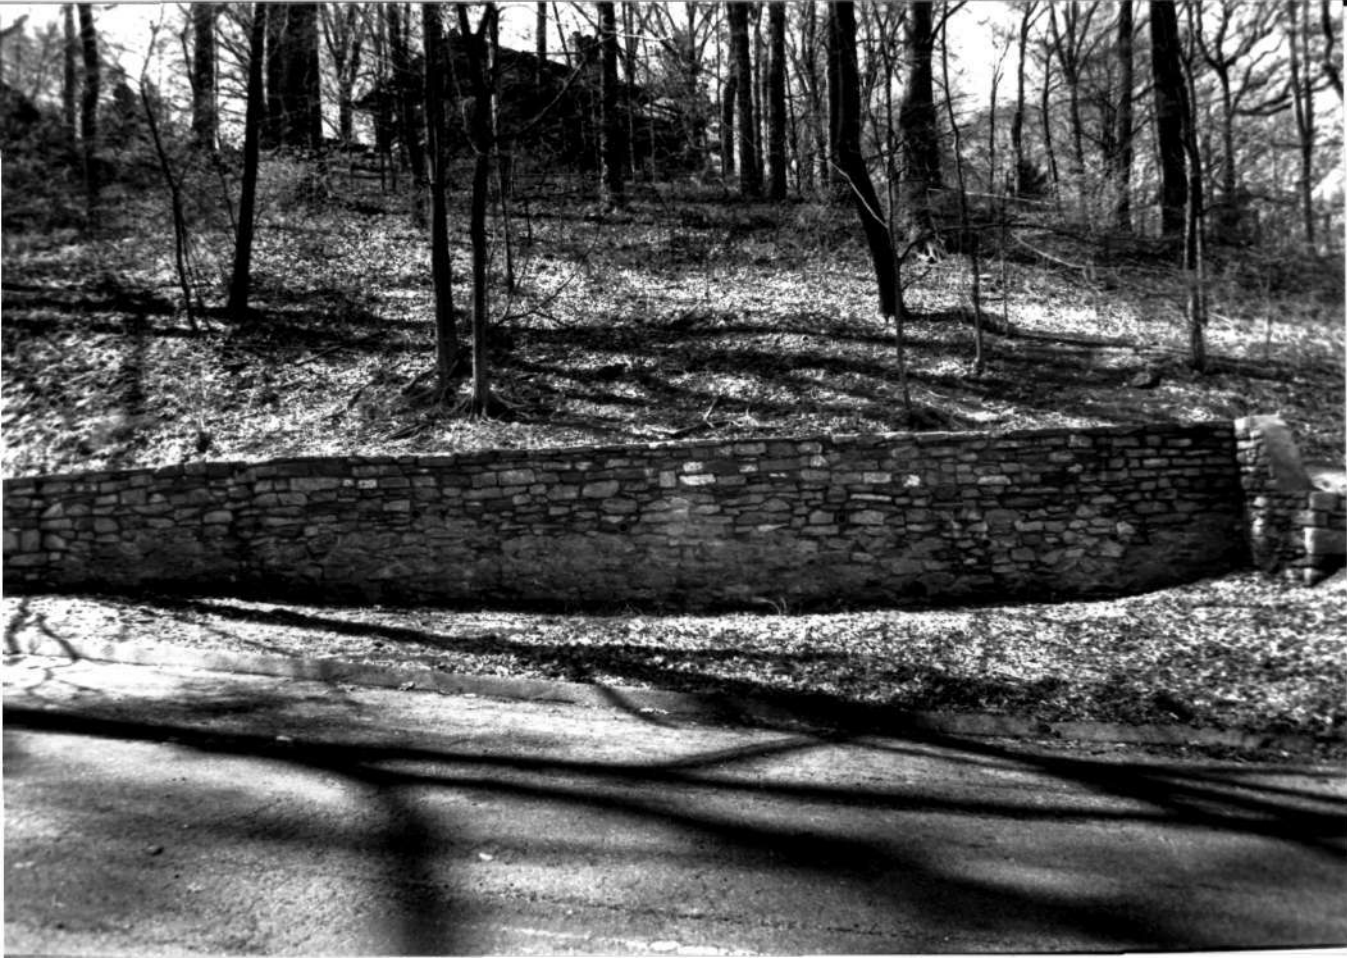
Foundation Wall Looking West  
22 of 45

On the south side of the parking area, is a stone foundation wall which is the remains of the original gatekeeper's cottage. The wall is "L" shaped in plan, is 57 feet by 5 feet 4 inches, 18 inches in width, and varies from 4 to 6 feet in height. The wall is made of coursed fieldstone. The foundation wall is a contributing resource with a low level of integrity and a high level of historic significance.

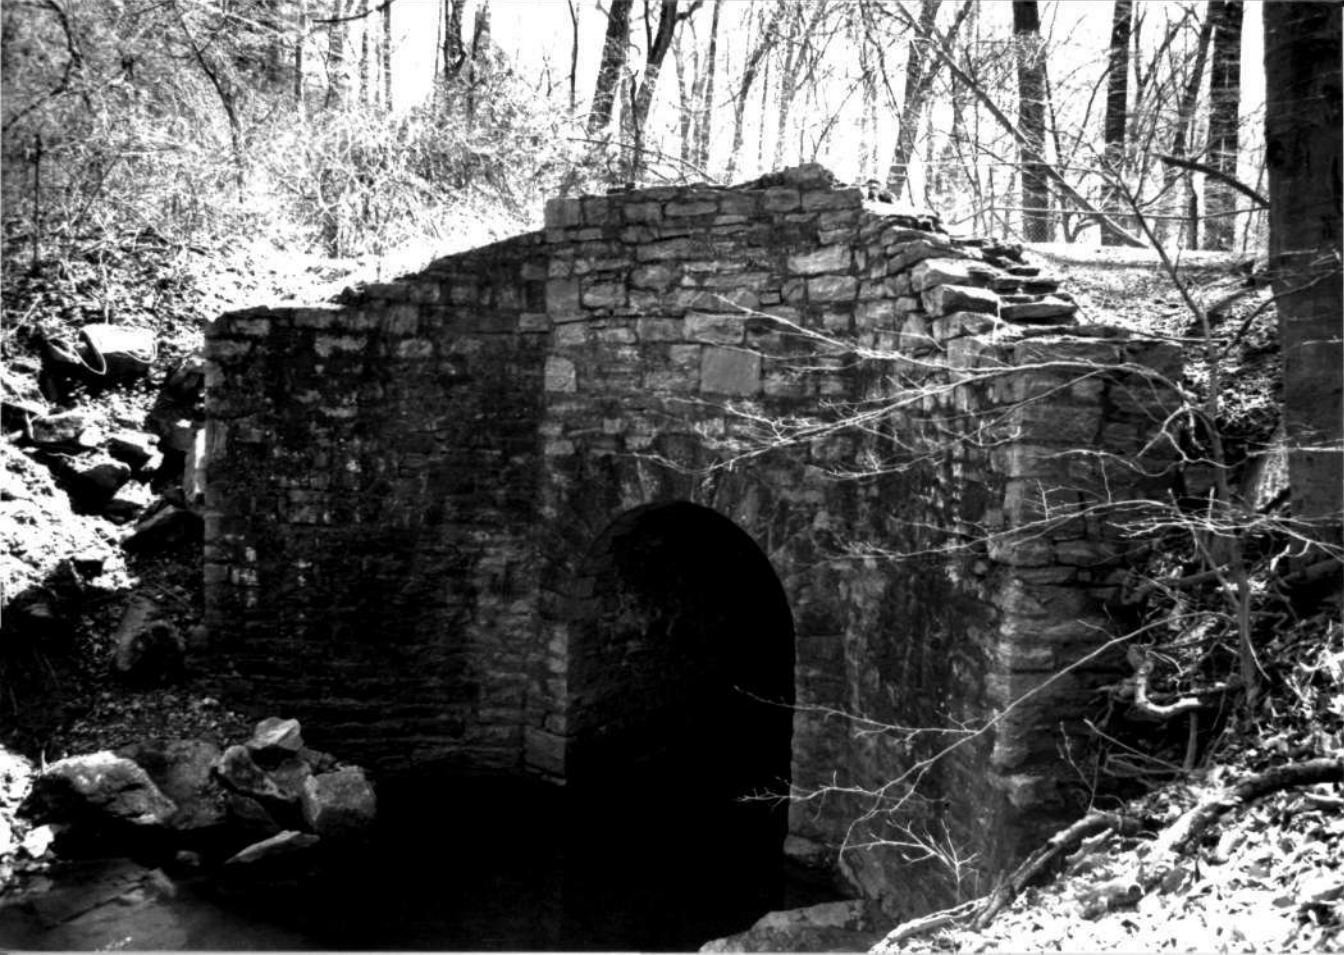
25 of 45 *Color*

Stone Bridge looking East

Lake Side Drive crosses a creek on an arched stone bridge approximately 750 feet north of the parking area. The circa 1862 stone bridge is built of squared and roughly coursed fieldstone with cut limestone voussoirs, and has a single Roman arch with a span of approximately six feet over the creek. The stone wing walls project above the road surface to form solid railings. Although the railings are missing some coping stones, the bridge is

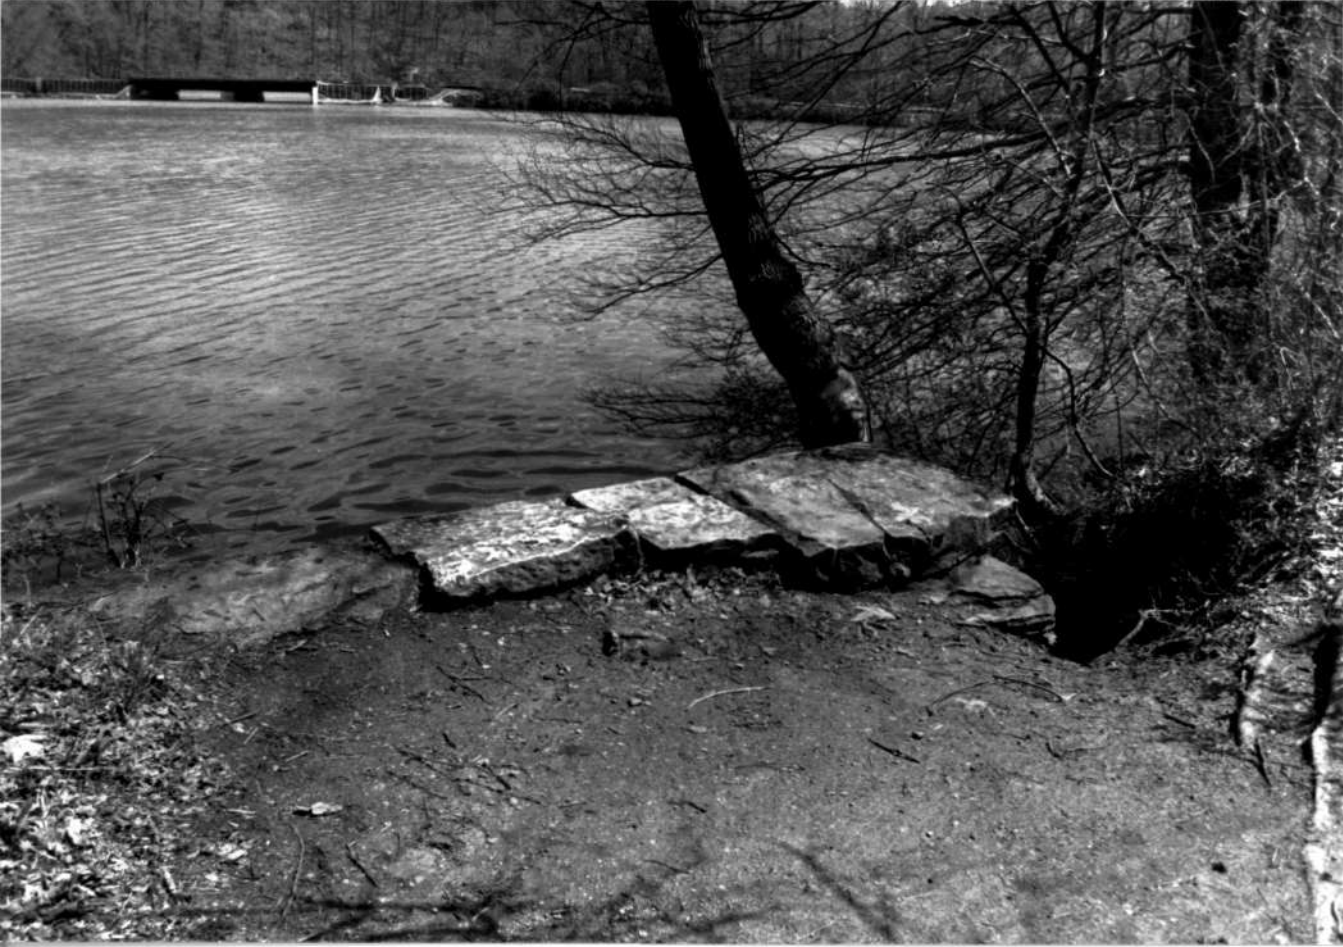
37 of 45

Top of Stone Culvert at Green Spring Valley Line

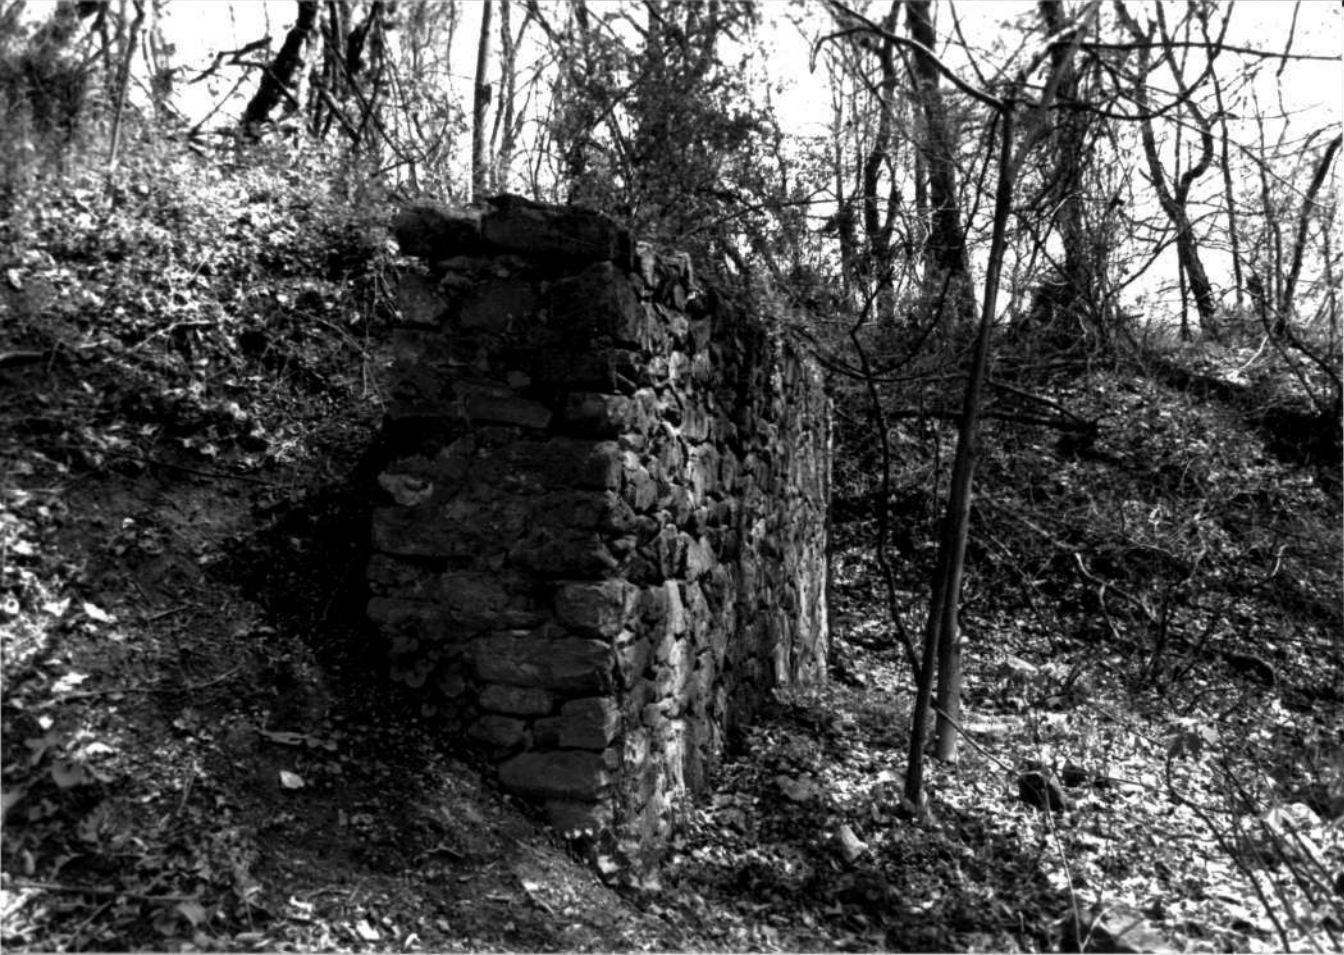
39 of 45

Retaining Wall at Green Spring Valley Line West Elevation

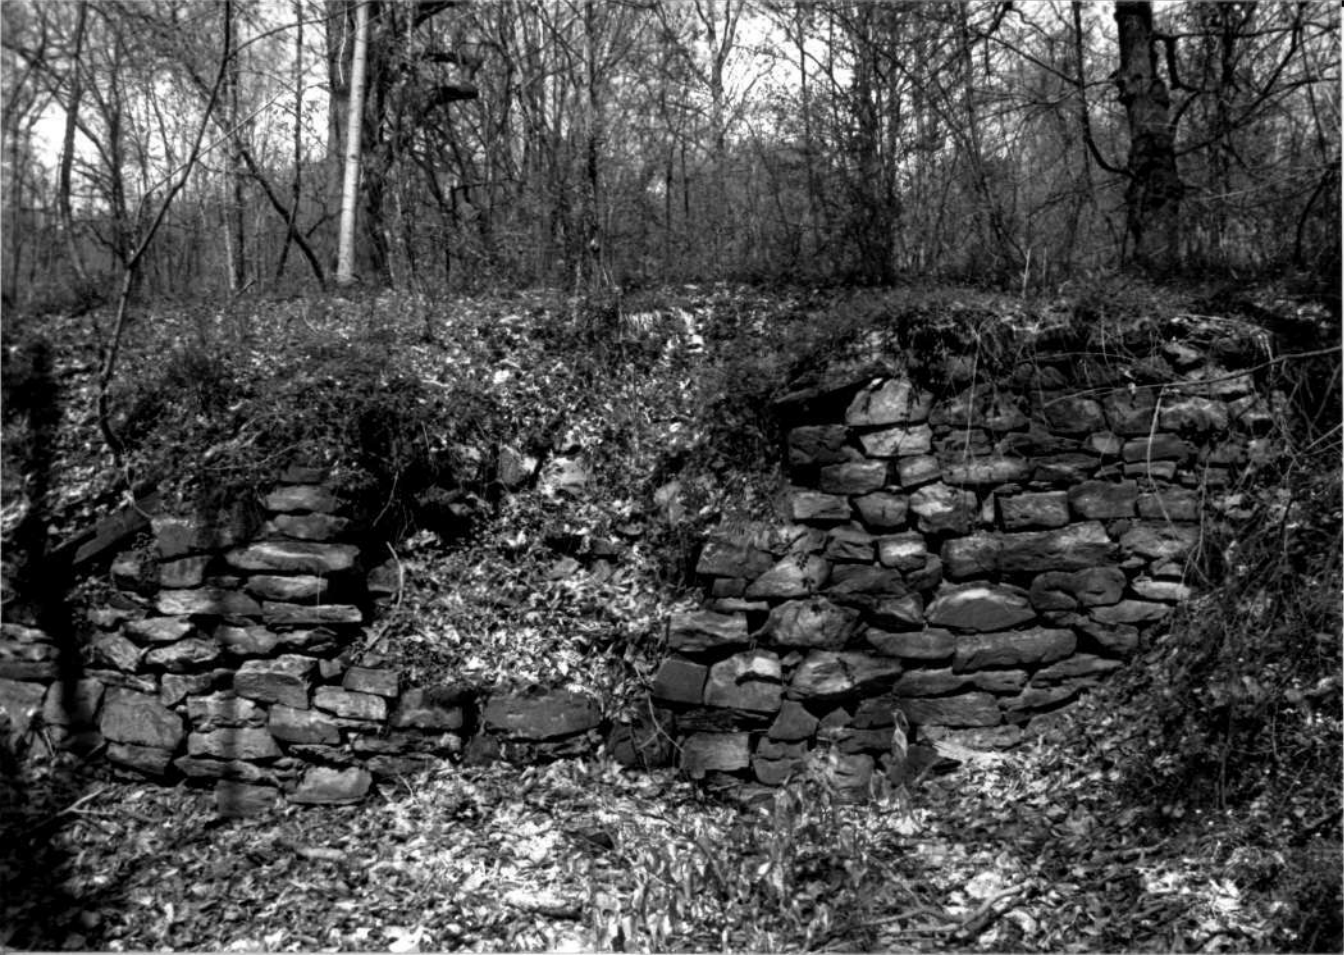
40 of 45

South Abutment at Green Spring Valley Line North Elevation

A pair of circa 1859 bridge abutments are located approximately 1400 feet west of the Northern Central line along the Green Spring Valley R.O.W. on either side of a small creek. The walls are constructed of fieldstone masonry with a soft mortar. The north abutment is unaltered and only the foundation of the south abutment remains. The abutments are a contributing resource with a low level of integrity whose contribution could be enhanced by sympathetic restoration.

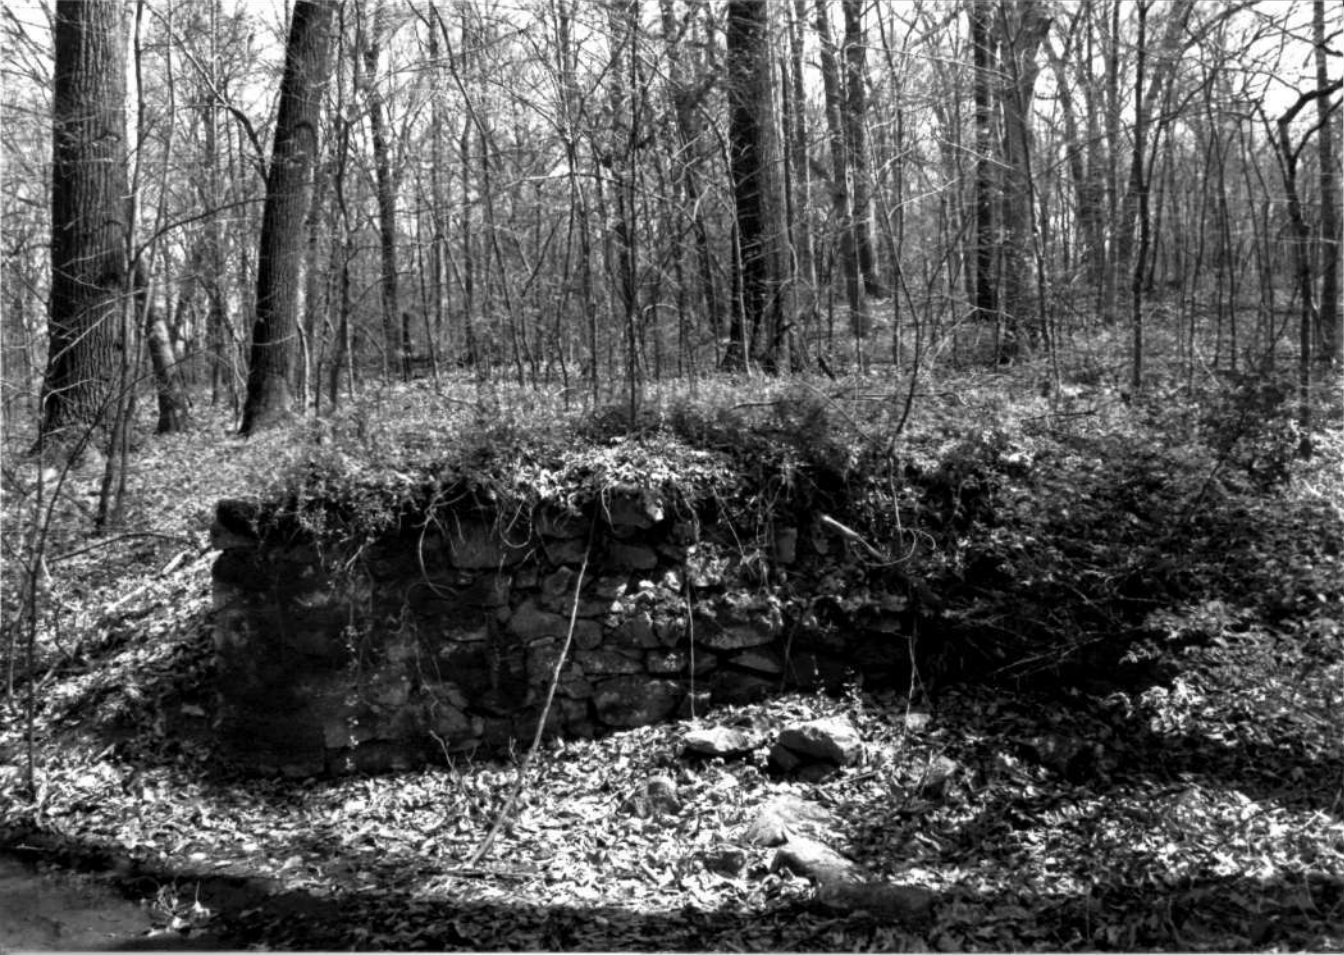
41 of 45

North Abutment at Green Spring Valley Line South Elevation

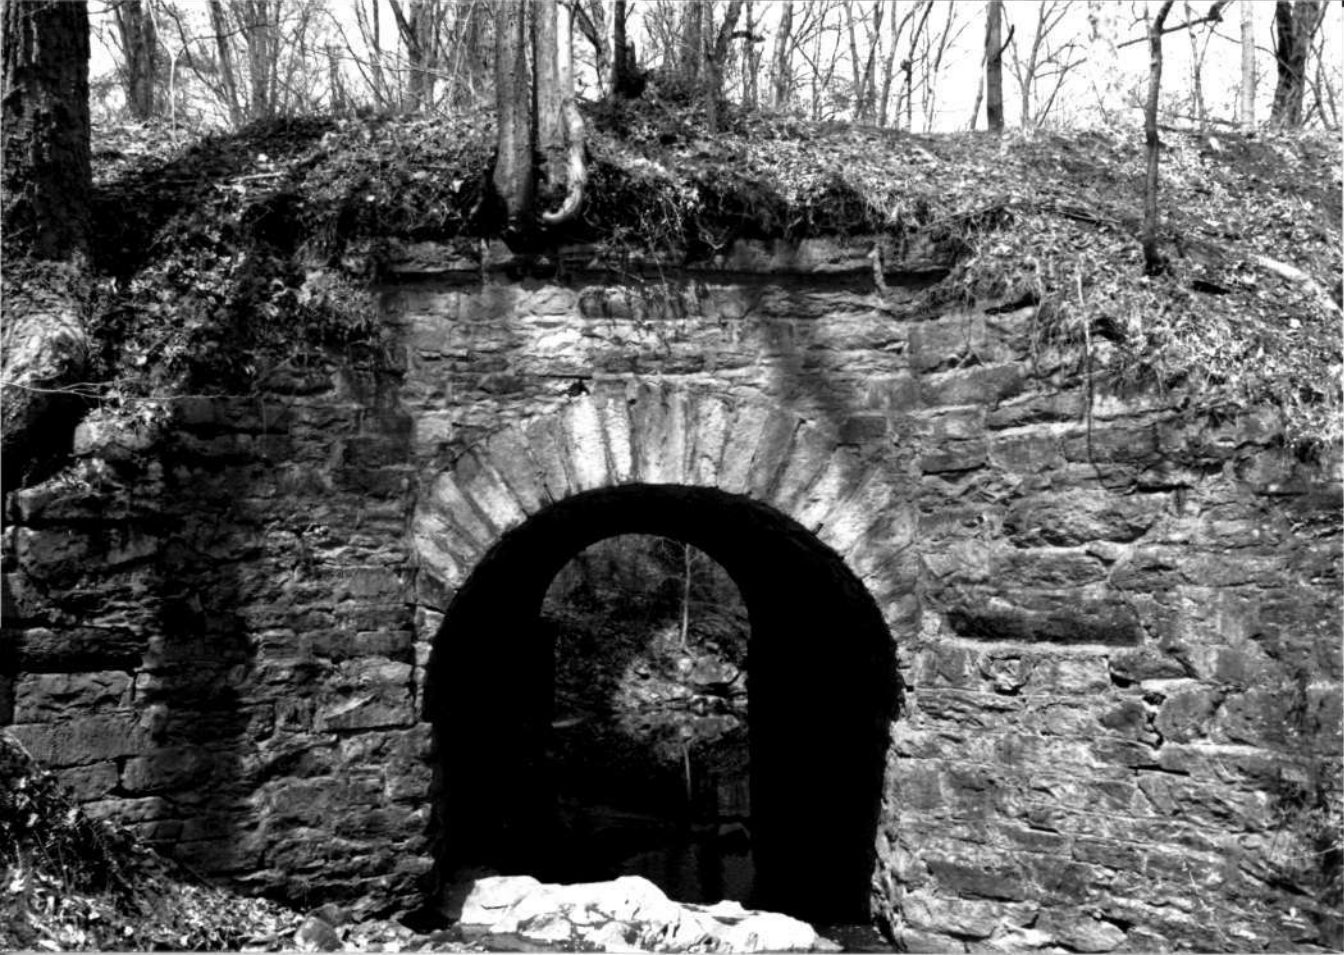
43 of 45 <sup>Culvert</sup>

Robert Macht, 6140 Barroll Rd, Baltimore, Maryland 21209  
Stone Bridge at Green Spring Valley Line South Elevation

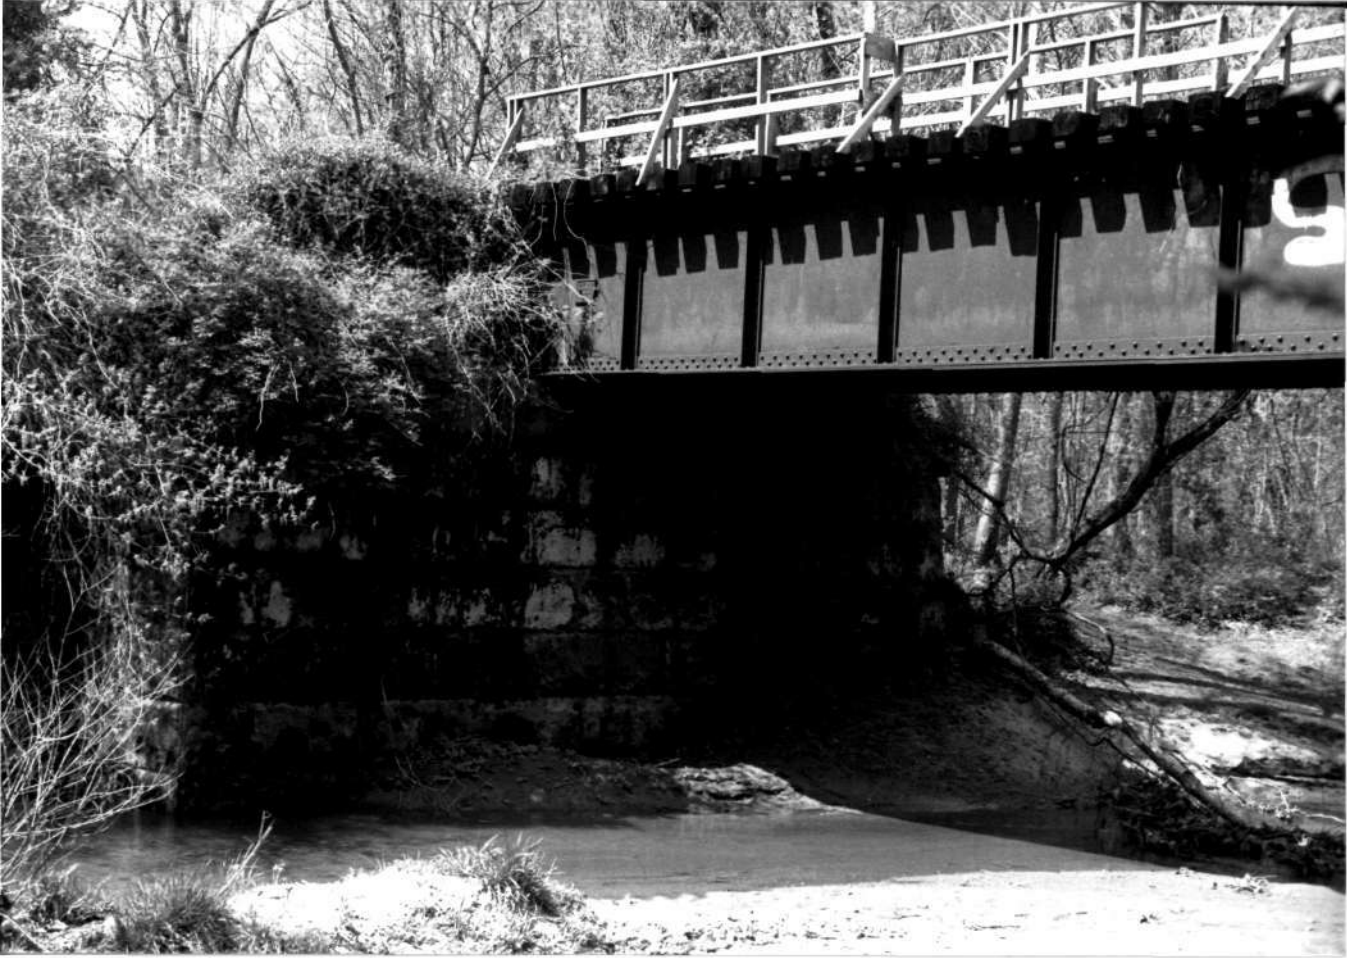
44 of 45

Robert Macht, 6140 Carroll Rd, Baltimore, MD 21209  
Girder Bridge at Jones Falls North Elevation
